Europa Nostra / EIB Institute

« The seven most endangered heritage sites »

St. George's Armenian Church, Mardin

Technical Report

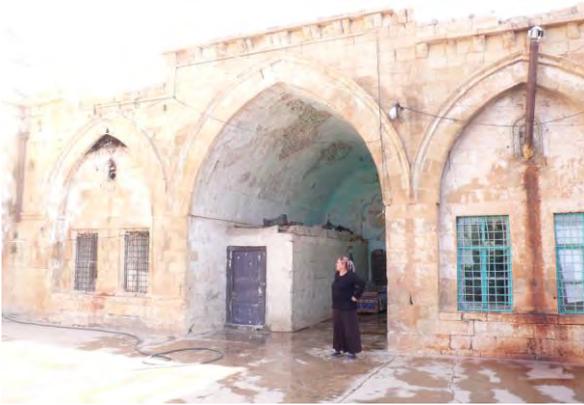
The other monastery buildings on the eastern side of the precinct are on two levels that of the terrace leading from the main entry door to the church entry (approximately level 0,00 m) and below on the level of the garden (approximately -6,30 m). The basic structures of these buildings remain, but are in need of repair and restoration. They have been modified over the years to suit the convenience of the various occupants. For example, rough brick additions to provide outhouses are visible as indeed are smoke stacks poking through walls and windows for wood burning stoves. On the lower level rudimentary waste water pipes

Monastery buildings showing non original structure and chimney

protrude from the ceilings to serve primitive toilet and washing facilities for the floor above. These pipes will all have to be removed. It will be necessary for the future use of the rooms on both levels to be carefully thought out and defined such that unobtrusive heating, washing and toilet facilities can be installed.

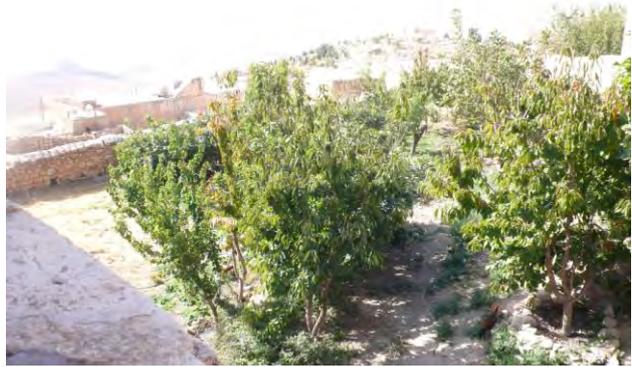
The garden just below the terrace is several metres higher than the rest of the garden and it is thought that the original earth infill of the church roof may have been dumped here during the roof repairs of 2002. The garden itself has been allowed to run wild and needs bringing back to its original levels and replanting, although it may be possible for some of the existing trees and bushes to be preserved. The perimeter wall surrounding the garden has been partially renovated but will need to be completed.

View from terrace of garden

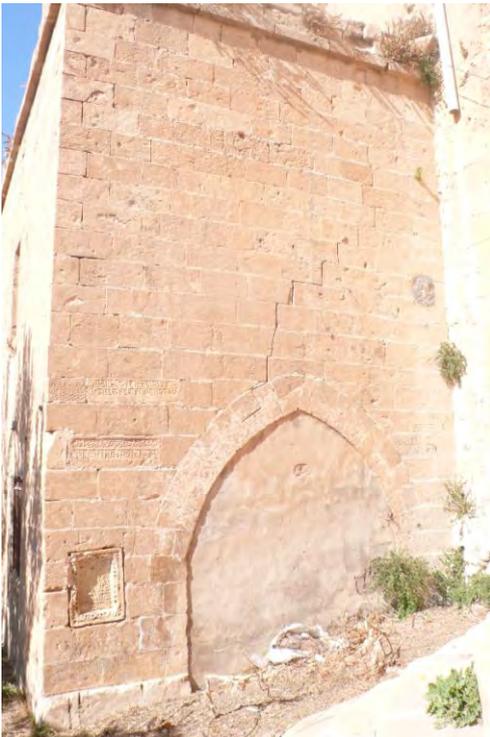
Structural cracks are visible and may be due to subsidence and/or the consequence of earthquakes (Shown at Appendix 8). However Mardin is some way from the main fault lines running east – west to the north of Mardin through Anatolia and to date has experienced only mild earthquake activity (Shown at Appendix 5). No serious differential settlement is observed on the stone walls, however, on the west wall of the church interior, vertical cracks have been observed. At the eastern end of the church, the arch over the apse has a vertical crack and the east wall of the priest room has three cracks which are gradually opening. On the east wall of the church, some of the corner stones are missing and there are also cracks which might grow and threaten the structure above.

Diagonal fissure above arch indicates subsidence and/or seismic effect

As an essential part of the structural repairs to the walls and roofs of the church and other monastery buildings, their level of seismic protection should be raised to the seismic standards relevant to and required for such buildings in the area of Mardin.

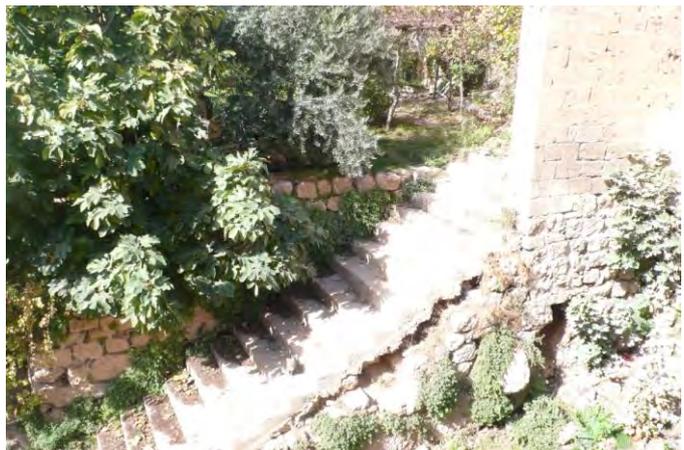
View of dilapidated steps from terrace down to garden level
