Prinkipo Orphanage Büyükkada-maden Mahallesi Istanbul

Structural Inspection

March 2019

HOCKLEY & DAWSON

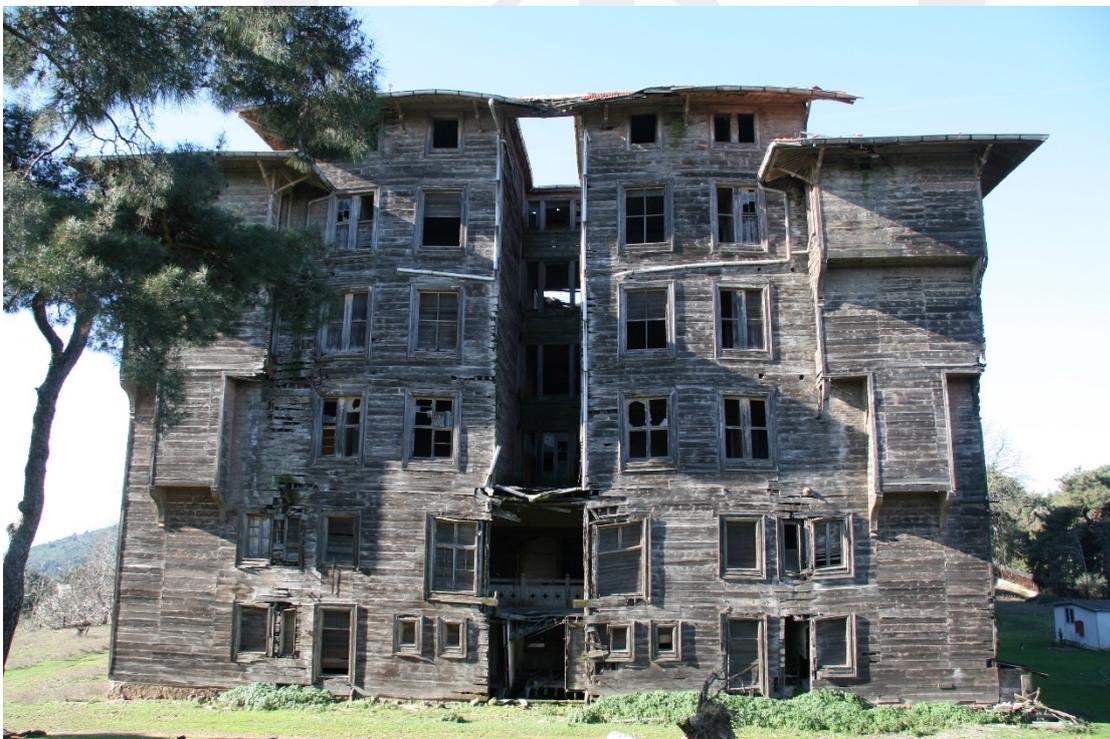
North elevation showing six storeys and double jetty at upper floors.

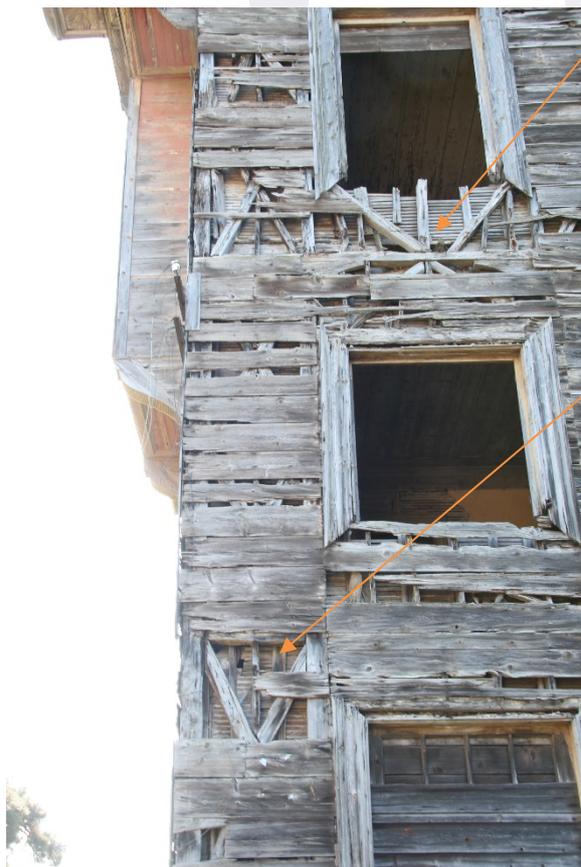
Bracing above and below windows.

Bracing to external wall visible through failed boarding.

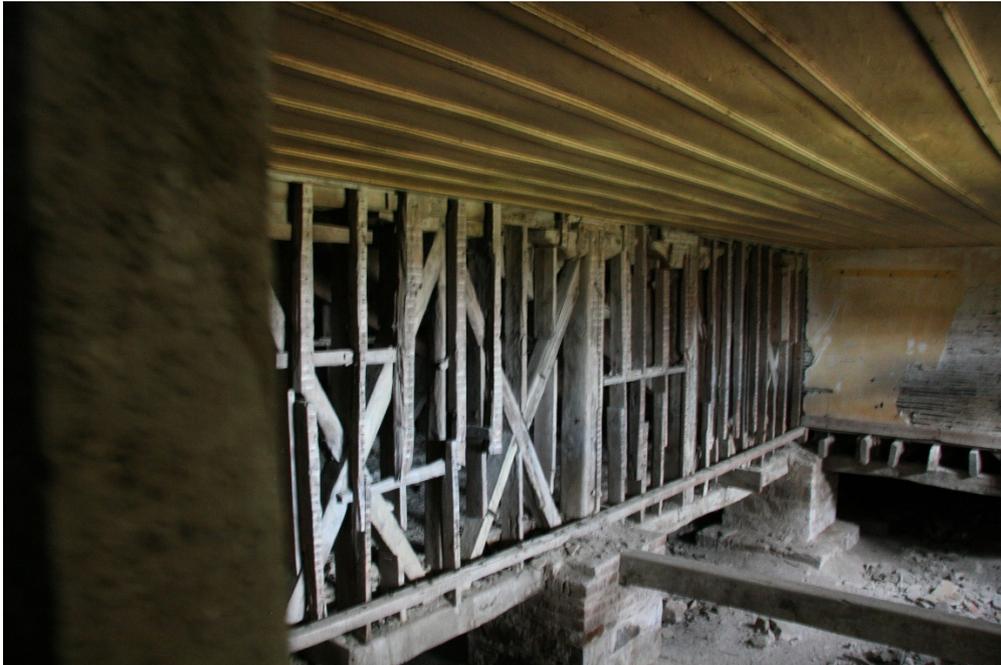
Pairs of braces in internal walls.

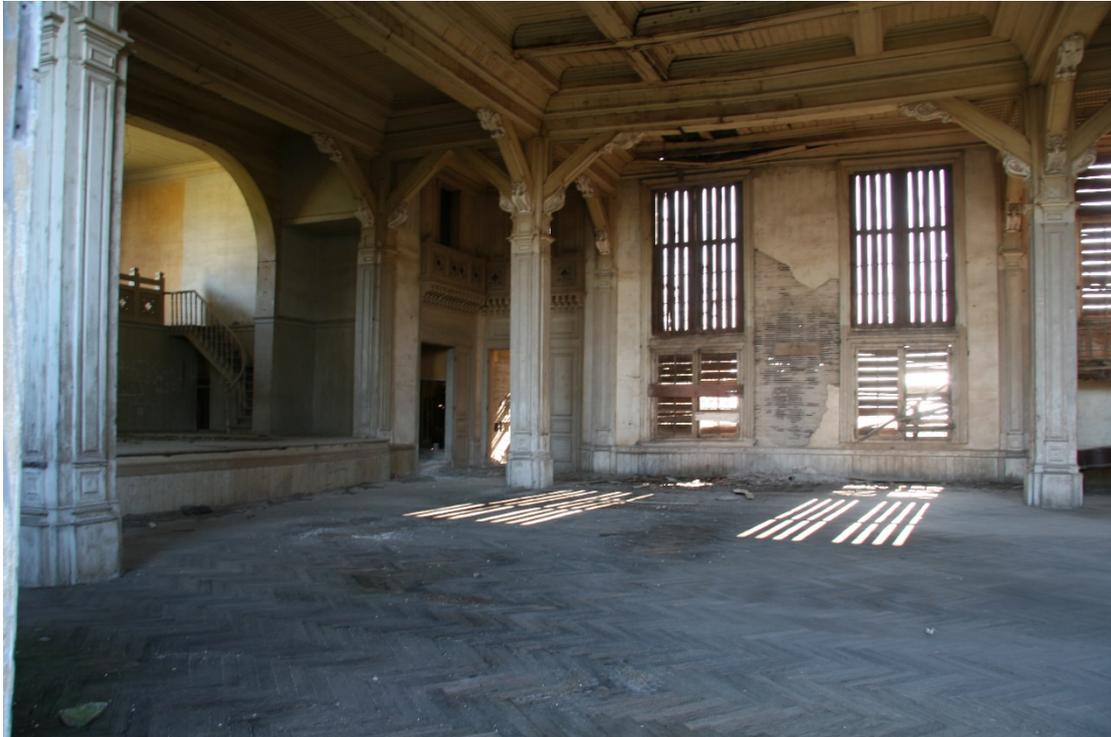
View of theatre with large span beams.

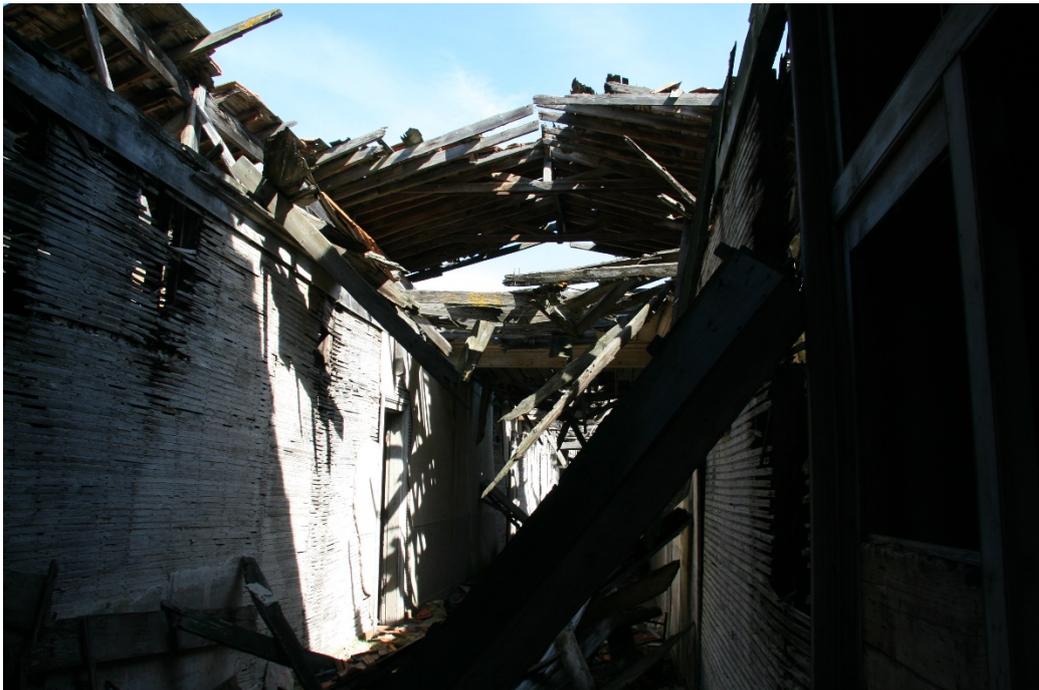
The structure is considered to be in a dangerous condition. Much of the roof has been lost with elements collapsed onto the upper floors or suspended from wall heads. Some elements are evident on the ground around the structure. A number of fallen tiles were noted internally several floors below roof level.

Collapsed roof over internal upper corridor

- 8.2 Replacement/repair of the major part of the roof structure.
- 8.3 Reconstruction of parts of the fifth and sixth floors to support the roof.
- 8.4 Repair of external structure as required including the replacement of decayed and missing members.

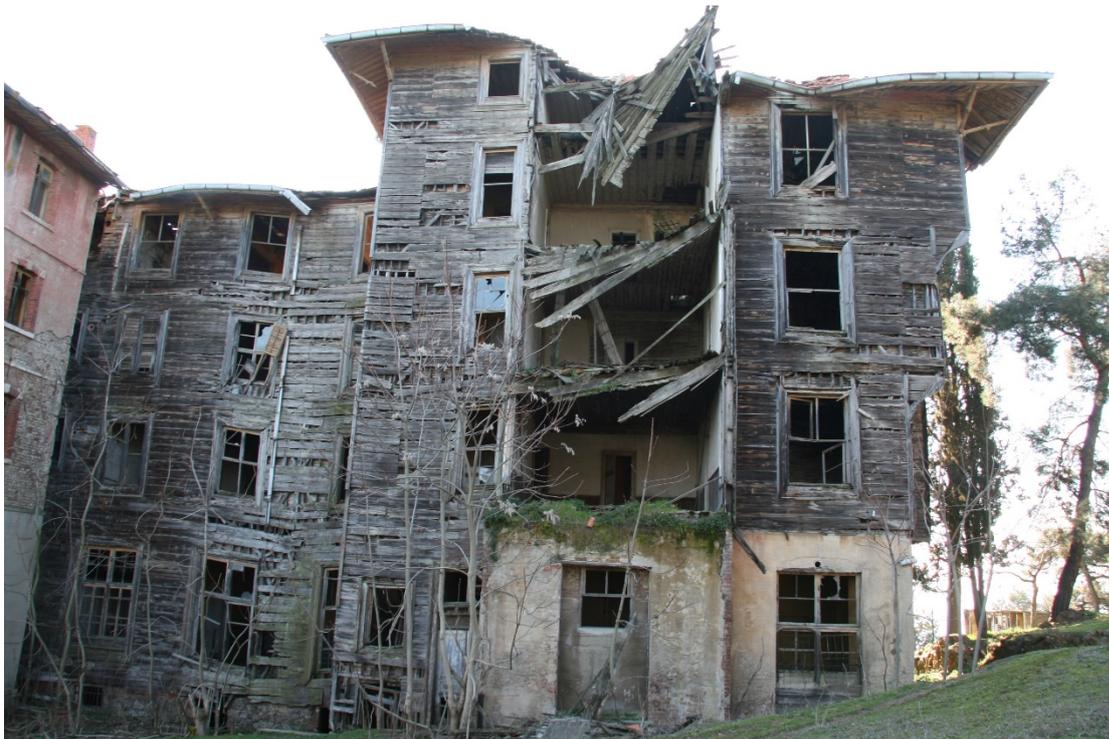
South end of west elevation.

Subsequent water ingress resulting in timber wet rot and a loss of lateral restraint previously provided by the roof has resulted in a failure and loss of some internal and external wall panels. This is particularly evident on the west elevation where roof and external wall failure has led to the loss of some floor elements leaving significant structure unsupported and hanging.

Sections of timber boarding and in particular the corner fillets have failed allowing water ingress and subsequent loss of structure. This is particularly evident on a number of external corners where the corner post has decayed completely.

- 8.13 Review external cladding corner detail to try and prevent previous premature failure.
- 8.14 Repair masonry structures as appropriate.
- 8.15 Reconstruct fallen flue.

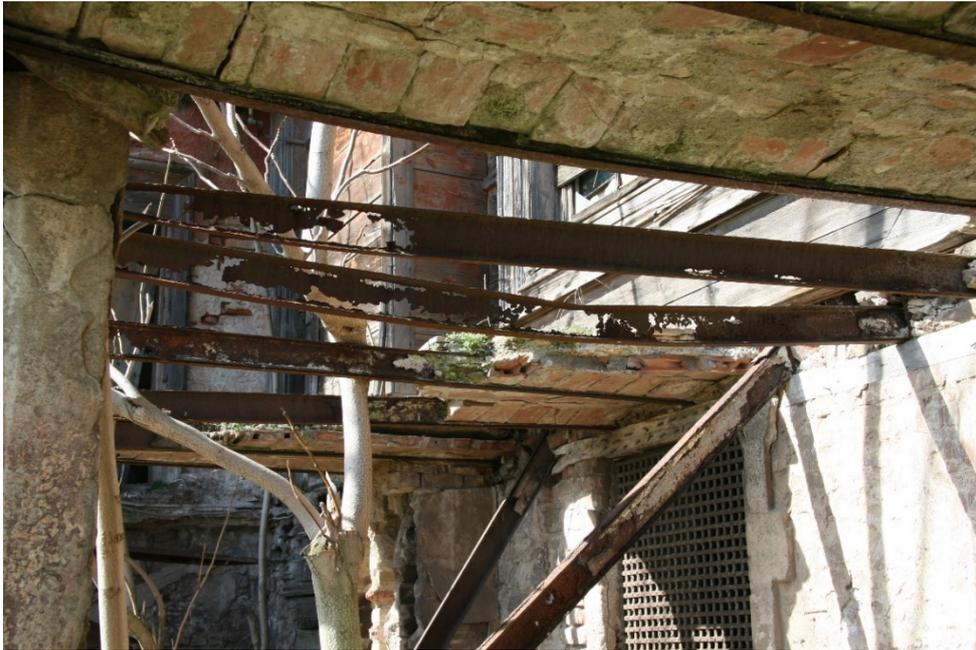
The east terrace and its protective roof is in poor condition with severe decay to some of the steel beams and the roof largely lost.

Steelwork to east terrace.

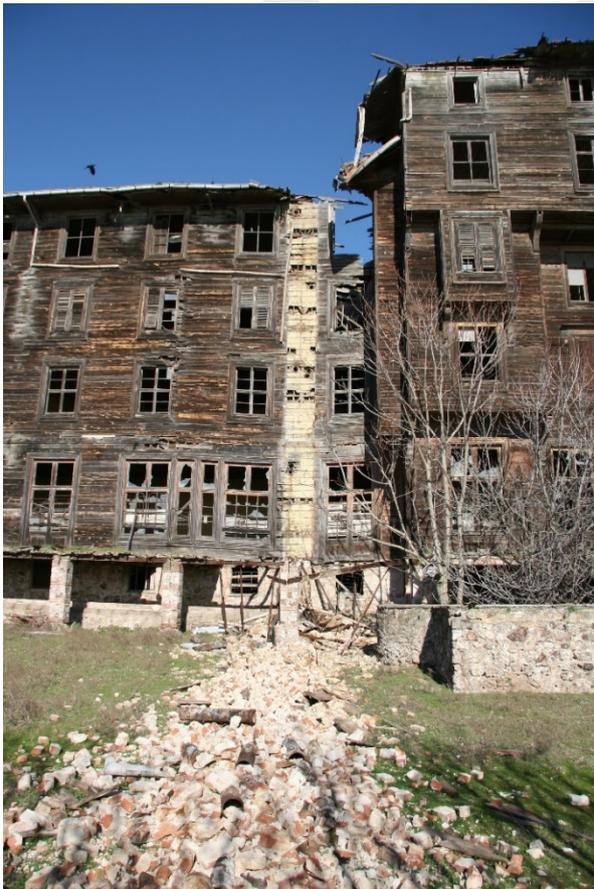
One of the masonry full height flues has recently failed and now lays where it fell.
