## **Post Byzantine monuments in Voskopoja and Vithkuqi Albania**

### **Technical Report**

**Peter Bond**  
**Lourdes Llorens Abando**  
Consultants EIB Institute  
Luxembourg

10<sup>th</sup> December 2018

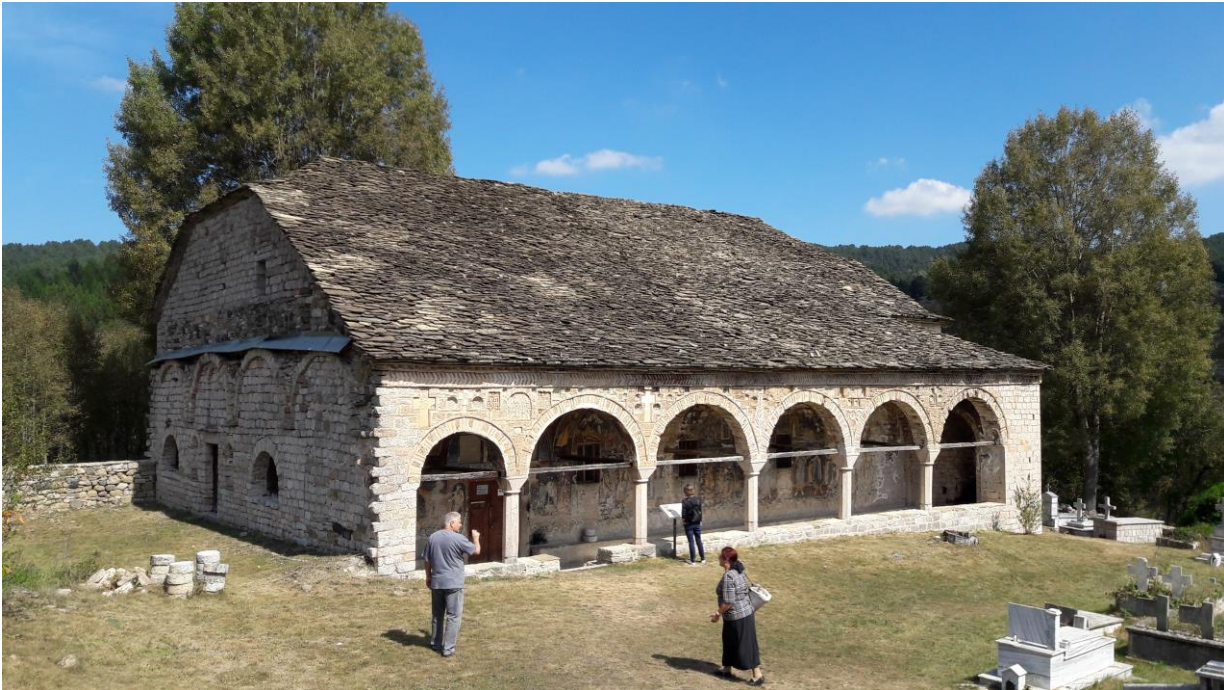
St. Athanasius (mission's visit).

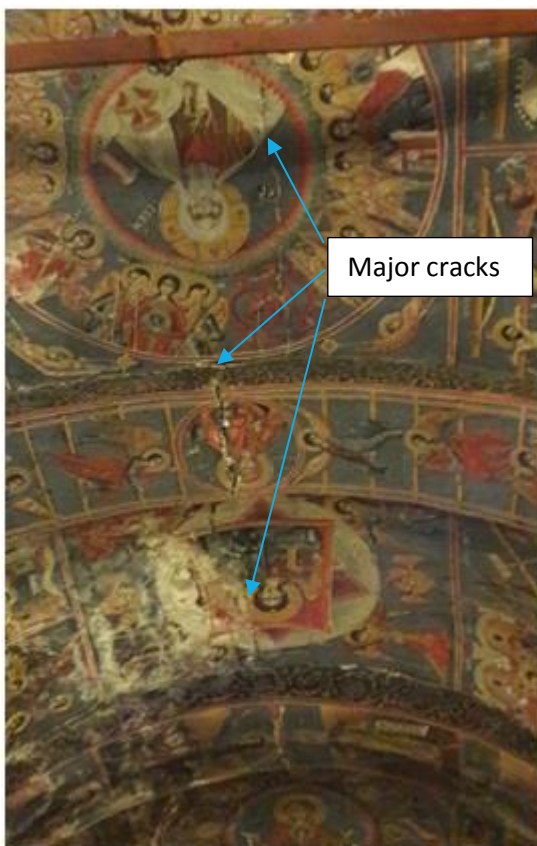
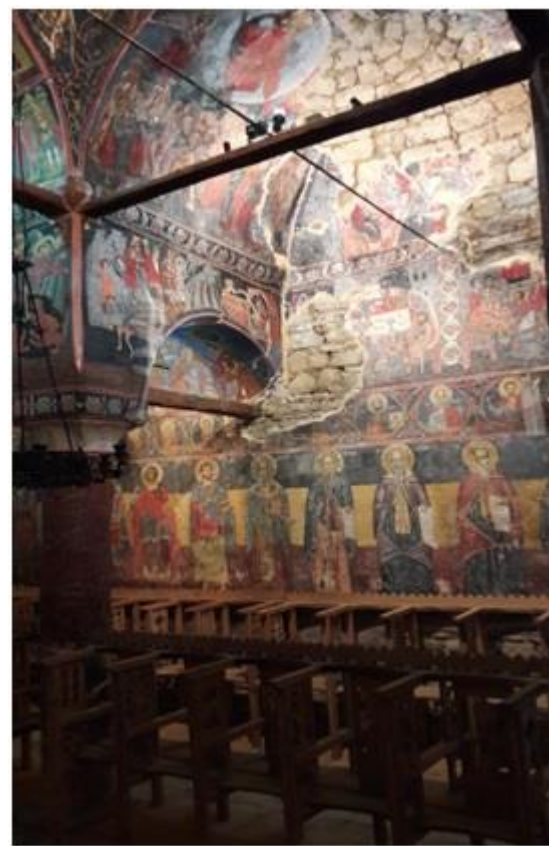
Frescos – splendour, cracks and damage.

The mural paintings in the Churches of Voskopoja and Vithkuqi are preserved to different levels, but generally rather extensively. Damage on most of the painted surface is manifest through fall of paint and plaster, as well as loss of material and visual intensity of the colours, due to the effects of humidity and moisture. The mural paintings are made with the *a fresco* technique, and have an exceptional artistic and historic value. They are an integral part of the buildings and are a most important component for the perception of the space of the churches. To faithful people they also represent a fundamental spiritual support to experience the presence of the divine.

- Intervention on painted plasters should follow after the necessary structural intervention. Water leakage from the roofs or humidity coming from the base of the walls is a major threat for the conservation of plasters and should be eliminated before addressing the restoration of the painted surfaces.
