Zogu's Bridge, Albania Technical Report

Peter Bond
Consultant EIB Institute
Luxembourg

March 2023

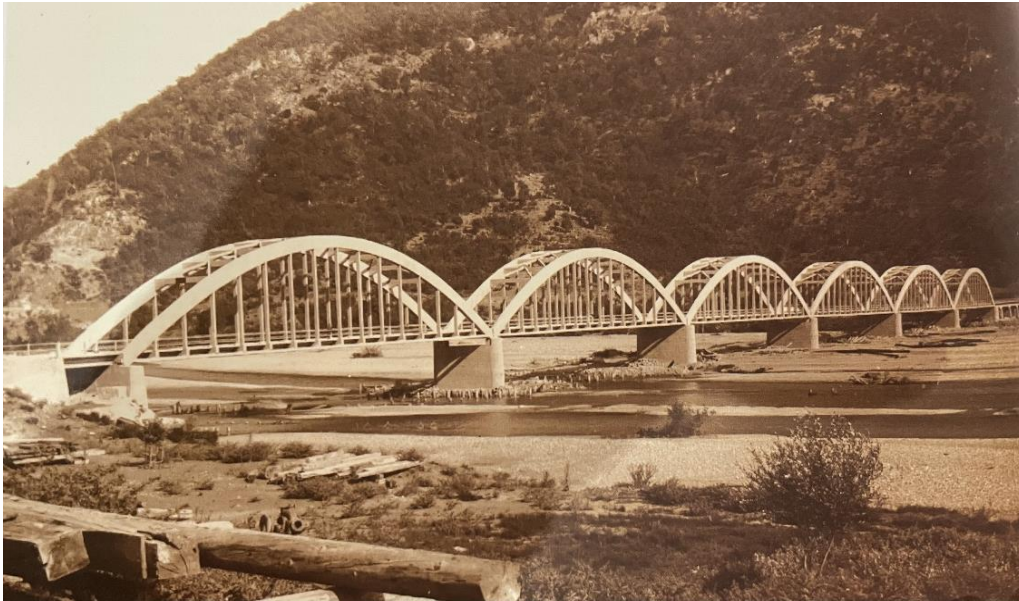
Zogu's bridge from the north-west shortly after completion.
(source "Italian architecture in Albania 1925-43 Armand Vokshi")

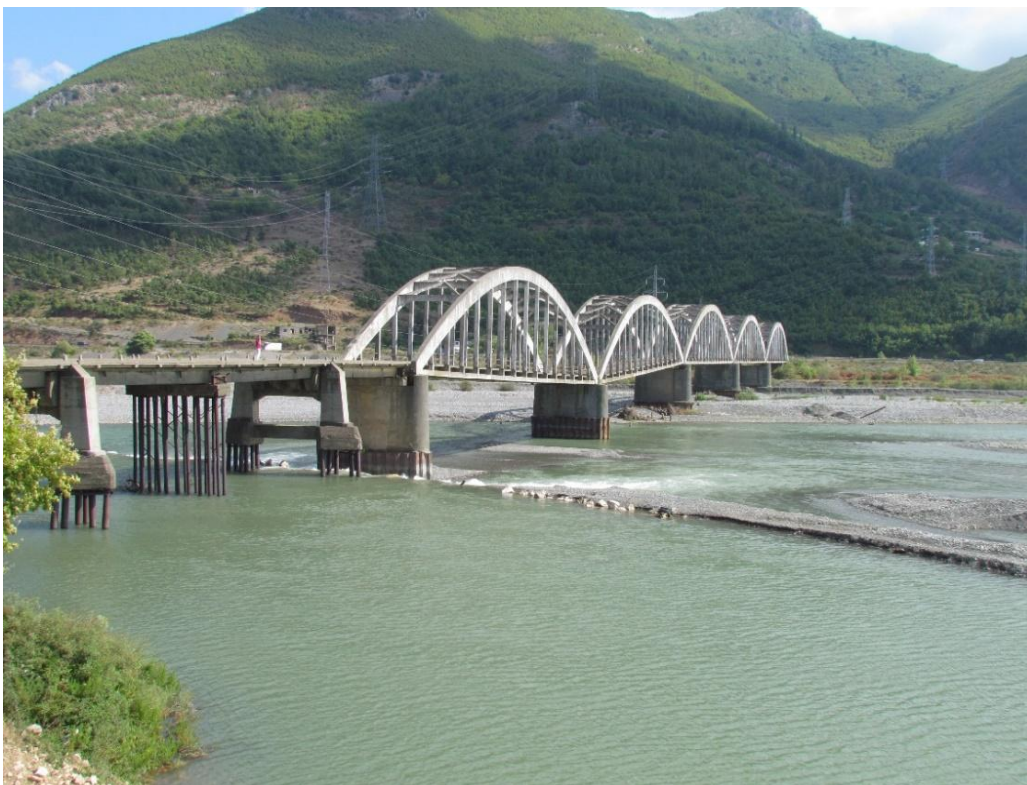
Zogu's bridge in 2022 from the north-west.

The bridge is nearly 100 years old and well exposed to the elements with a wide temperature range and often strong winds. With recent neglect the concrete has degraded with numerous cracks and steel being exposed with inevitable corrosion. The pier settlement has considerably worsened the state of the two adjacent spans with evidence of extensive cracking, particularly in the transverse bracing structure and flakes of fresh spalled concrete are clearly seen on these spans.

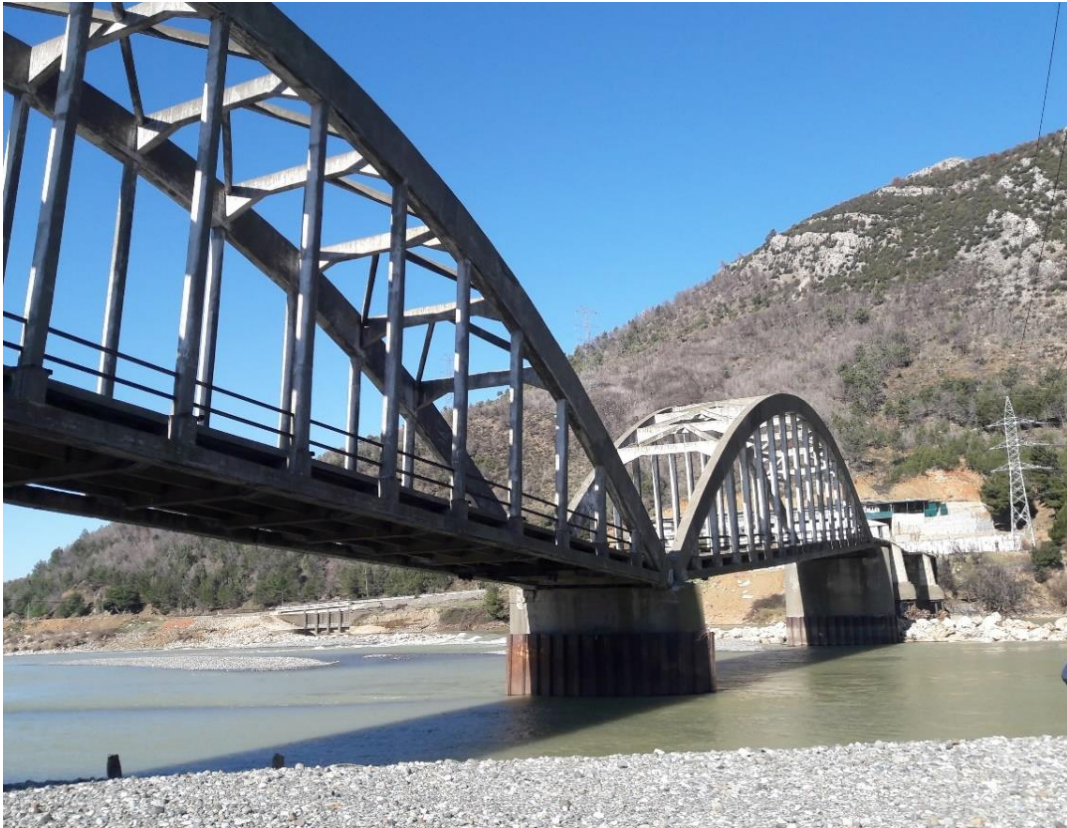
Pier No.5 and adjacent spans. February 2023

This degrading situation has become more serious recently with the settlement of one of the piers supporting two spans near the north end of the bridge. The river flow, especially under flood conditions, has undermined and eroded the alluvium at the pier whose foundation has clearly failed. Settlement of 4 m had occurred at the pier by mid-February 2023, and further movement is feared in the short term which could result in the spans falling into the river. This would be a disaster resulting in the loss of this important national treasure.

Details of the bridge piers and piled foundations are given in the original design drawings which still exist in the archives. It is assumed that they were constructed according to these drawings, which seems probable. Visual inspection shows that the piles have failed on the damaged pier with the pile cap settling some 4 m inside the surrounding sheet piles. The concrete piles have lost their friction bearing capacity, probably due to erosion of the gravel under the pile cap. It may also be that the sheet piles have been damaged underneath as they appear in poor condition near the surface. This damage would further encourage erosion under the piers. The 2019 earthquake may have contributed to this sheet pile deformation. More detailed study into the underground state of this pier would be necessary prior to reconstruction.

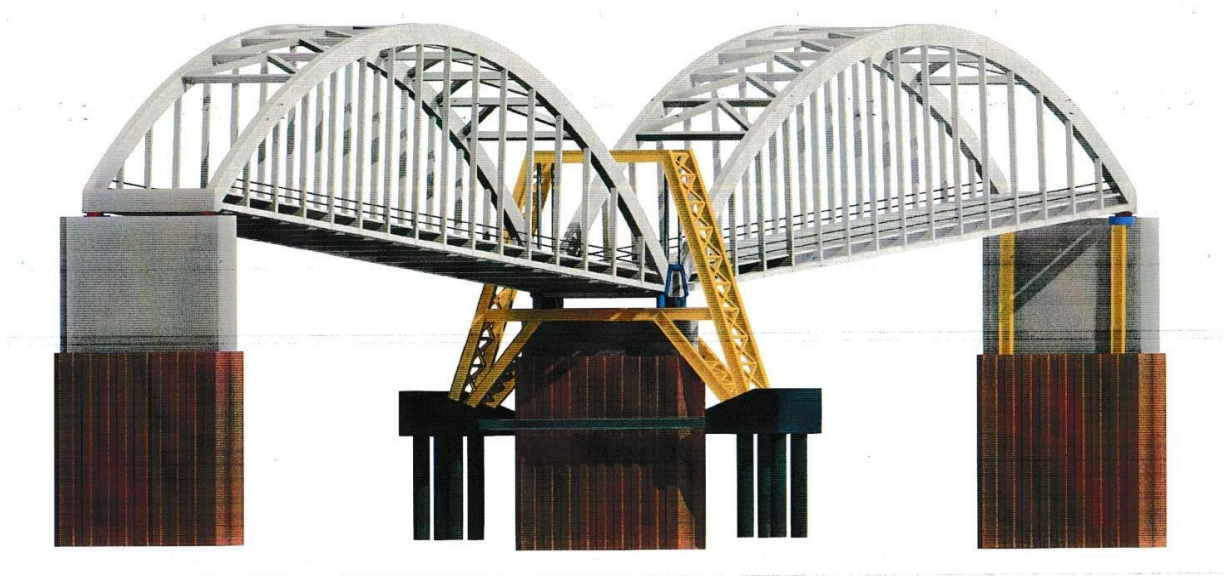
The proposed temporary structure to stabilise and restore the spans.
(Source: Technical Project UPT February 2023)

- Provide a support structure across the pier to relieve the pier of the load from the two spans thus avoiding further settlement. The proposed two-level steel structure would take the span loads initially at the lower level.

- The special structure, installed during Phase 1, is to provide the framework for heavy duty jacks via cables to move the two spans back to their original position. Details are still being developed.
- While the spans are suspended in their original position, the existing Pier no. 5 will be replaced by a new more robust one. Details are still being developed.
- As noted, the design of Phase 2 has not yet been finalised and it will be complicated in concept and challenging to construct. Other options may be considered and could be adopted to achieve the same objectives.

The spans each weigh about 500 tonnes and the classical technical solution of lifting the two spans off the pier by cranes is not possible as this equipment is unavailable. The concept proposed to support the two spans initially, thus avoiding further settlement, and then to restore them to their original position by means of a double function support structure is ingenious. However, details still need to be agreed on how the span raising operation and the application of the motive force, presumably via hydraulic jacks, will work in practice in both phases, initially by underpinning and then by lifting. The stability of the steel structure during the raising operation (with a 4 m lift) will need special attention. Note that the wind blows very strongly down the valley. A physical monitoring system has already been set up to track changes in the movement of the piers and this is an excellent initiative, providing advance warning.

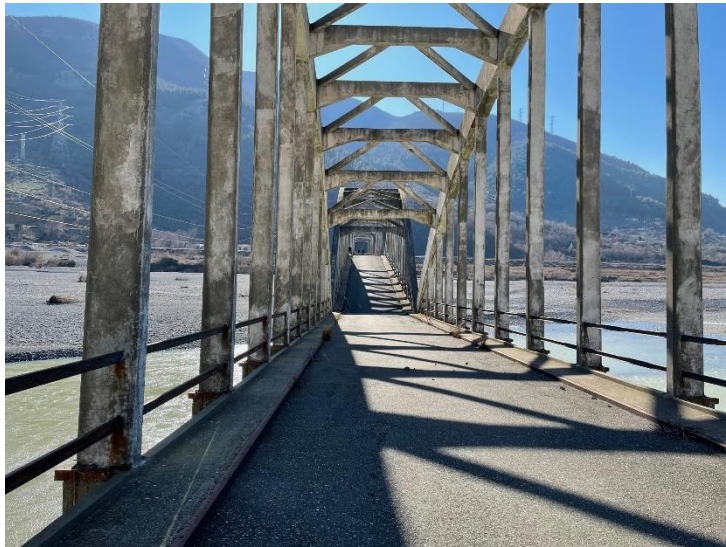
View looking south. February 2023

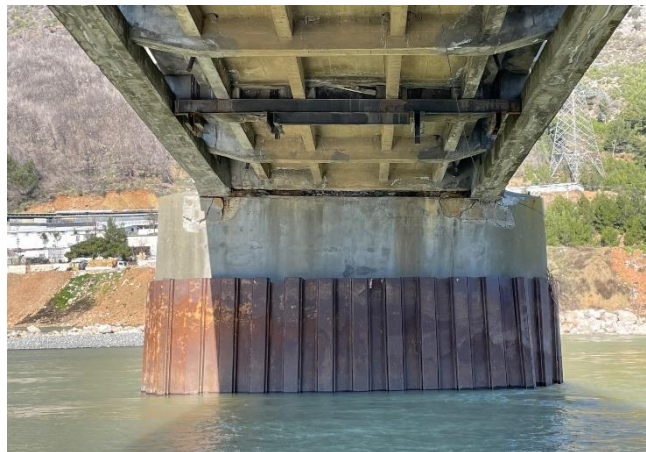
Pier No. 5 from the south. February 2023

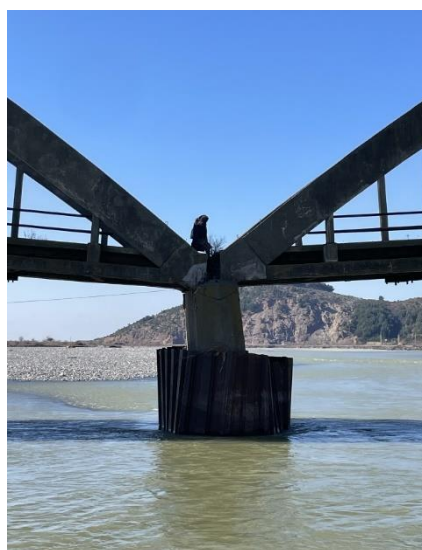
Pier No. 5 from the east. February 2023
